**Re: Bishops Lodge; Construction Stormwater; SIC 1522; NPDES Compliance Evaluation Inspection;
NPDES #NMU001971; May 23, 2018**

NPDES Compliance Inspection Report

**HRV Hotel Partners
NMU001971
January May 23, 2018**

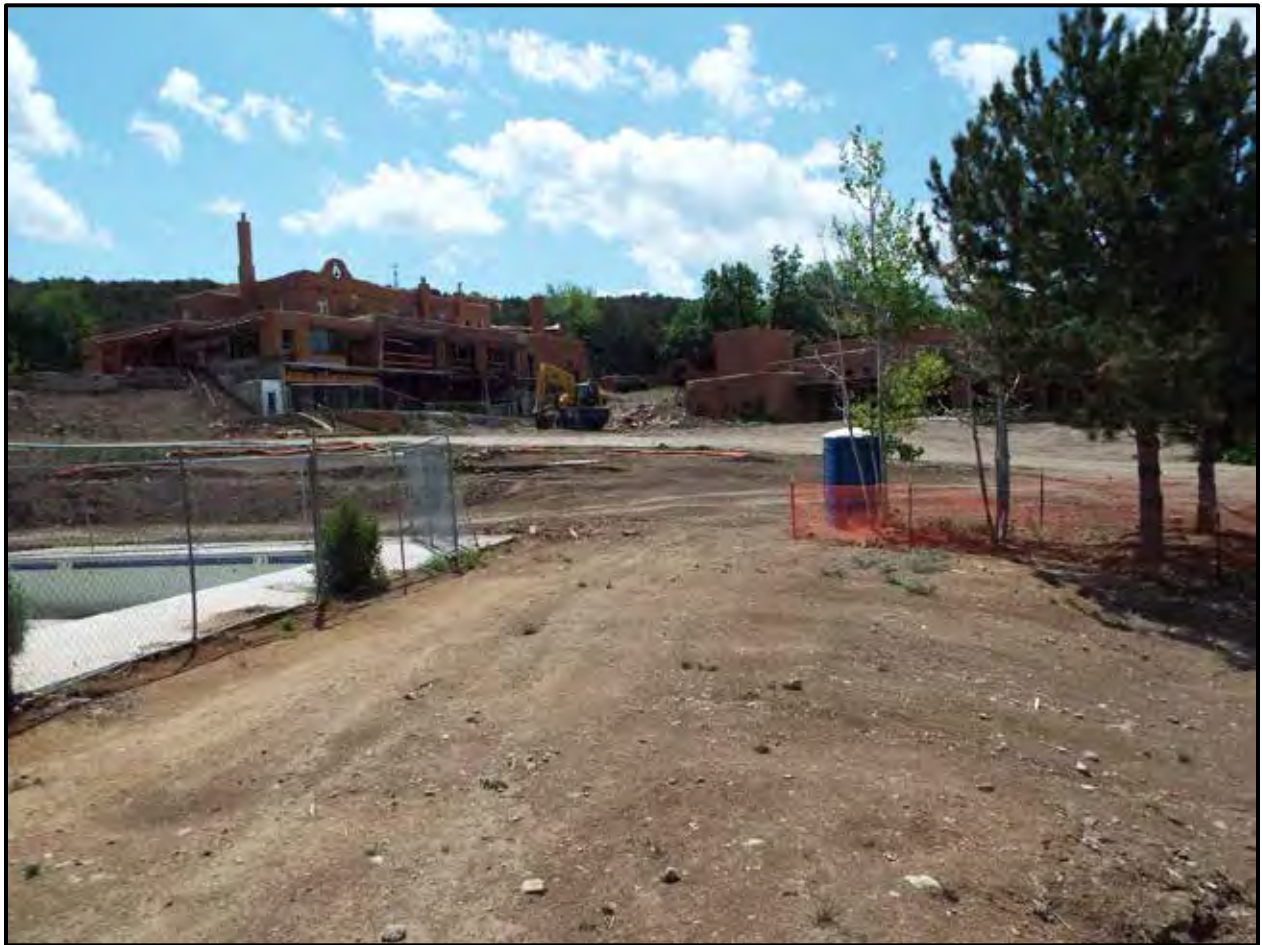
Photo # 1

Photographer: Daniel Valenta	Date: May 23, 2018	Time: 1125 hours
City/County: Santa Fe/ Santa Fe County		
Location: 1297 Bishop's Lodge Rd., Santa Fe, 87506 New Mexico		
Subject: The old Bishop's Lodge main office building which may date to the 1920's.

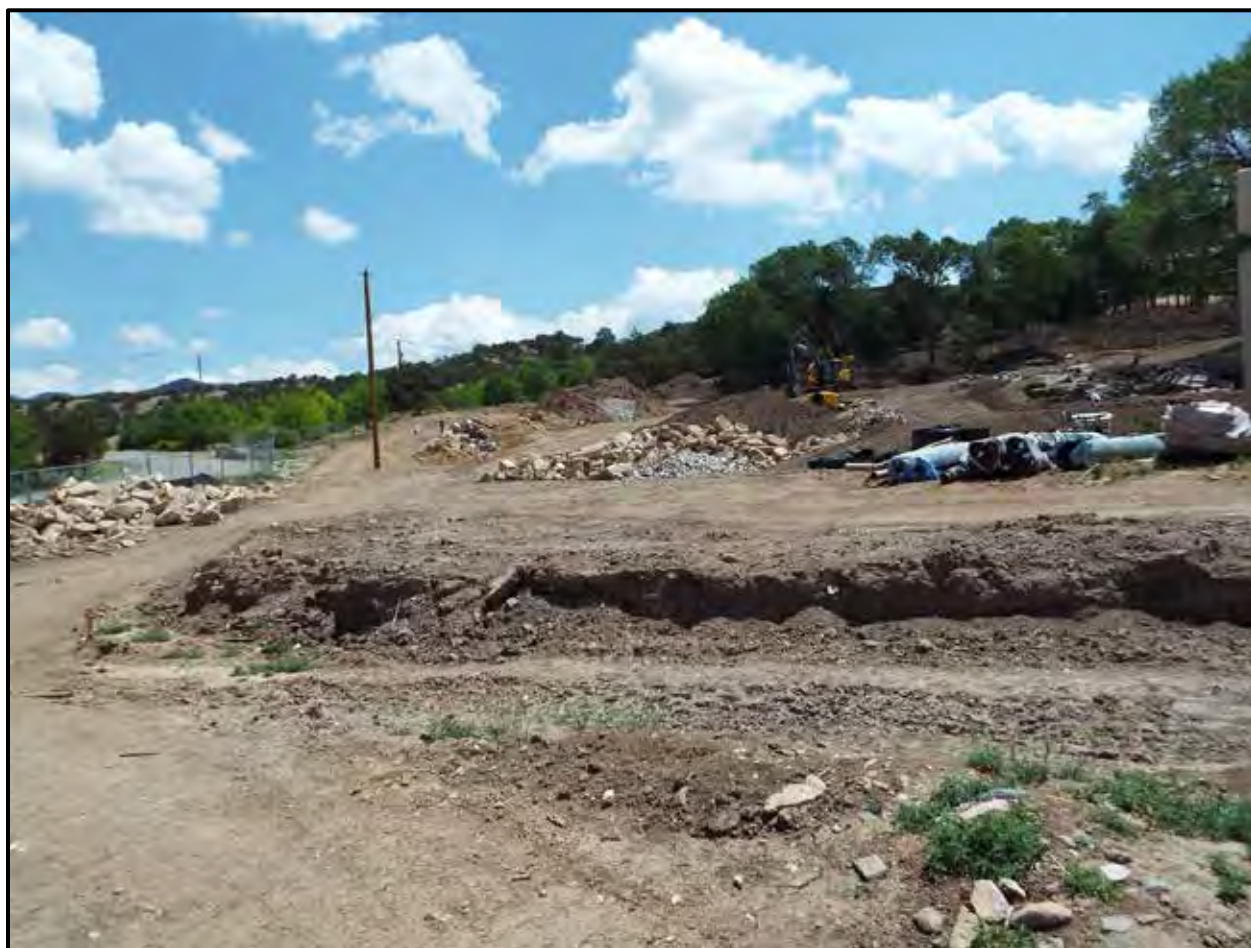
Photo # 2

Photographer: Daniel Valenta	Date: May 23, 2018	Time: 1153 hours
City/County: Santa Fe/ Santa Fe County		
Location: 1297 Bishop's Lodge Rd., Santa Fe, 87506 New Mexico		
Subject: Bishop's Lodge construction site.

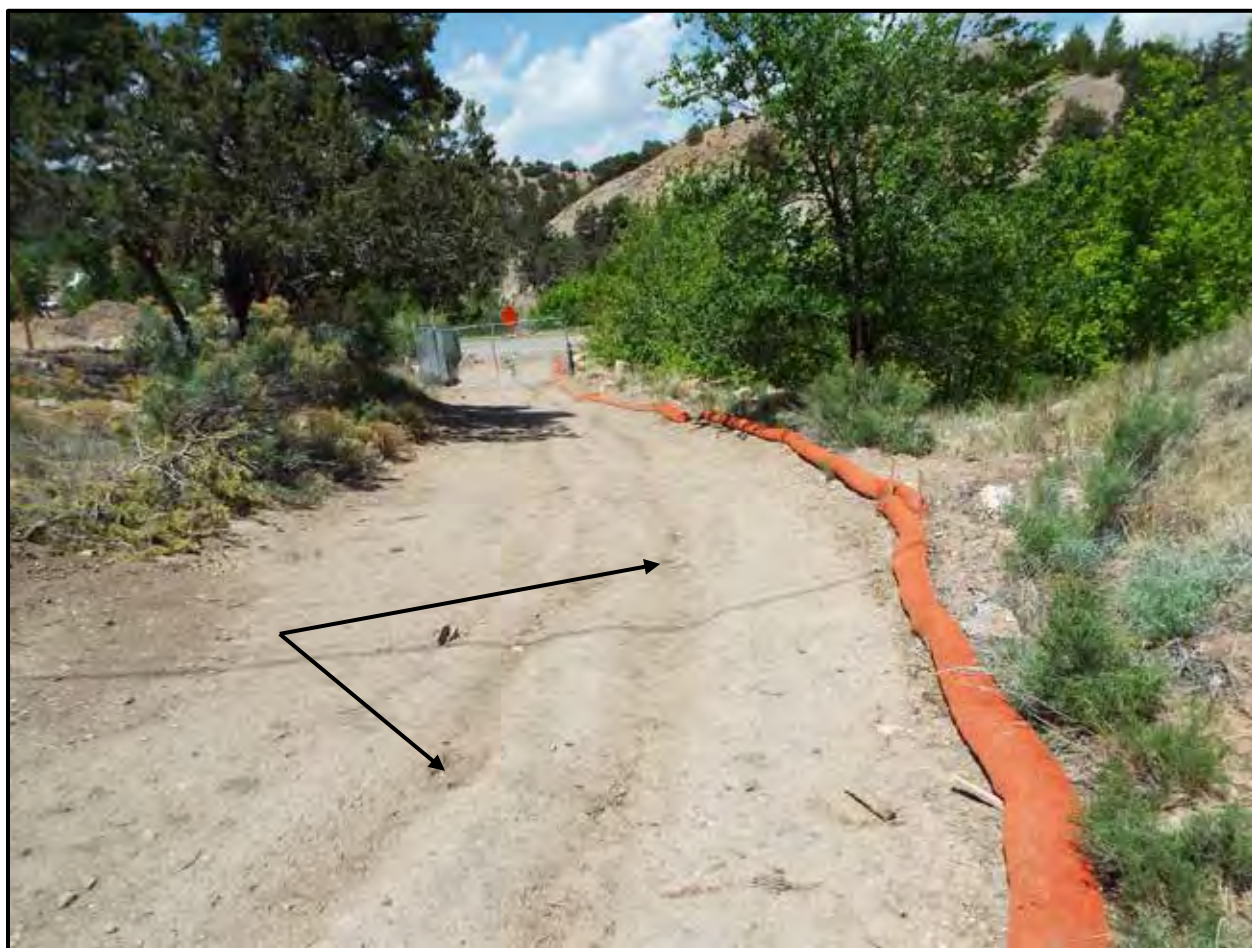
Photo # 3

Photographer: Daniel Valenta	Date: May 23, 2018	Time: 1157 hours
City/County: Santa Fe/ Santa Fe County		
Location: 1297 Bishop's Lodge Rd., Santa Fe, 87506 New Mexico		
Subject: Side entrance, fenced, to construction site. Arrows point to what appears to be downcutting from discharges.

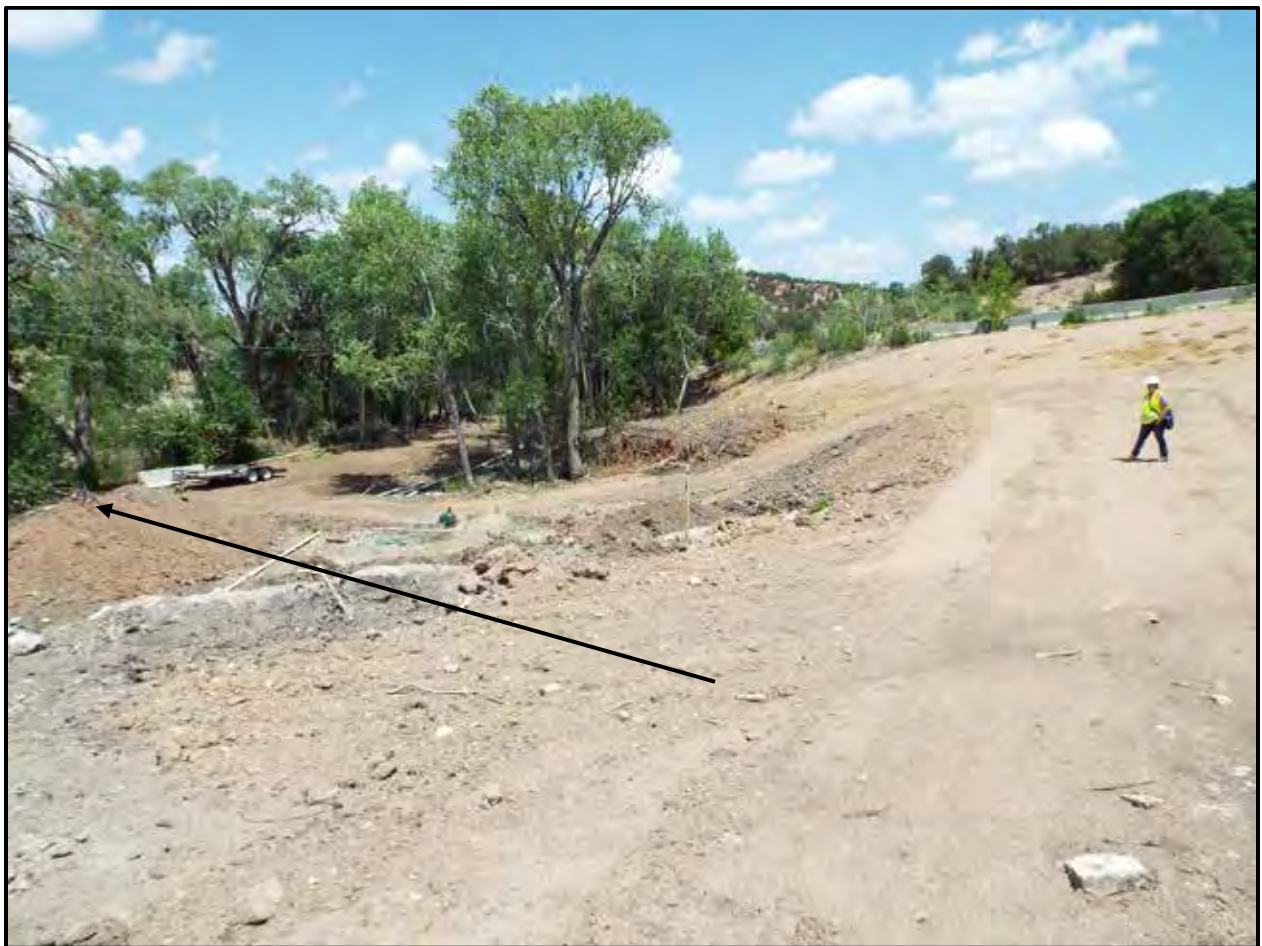
Photo # 4

Photographer: Daniel Valenta	Date: May 23, 2018	Time: 1204 hours
City/County: Santa Fe/ Santa Fe County		
Location: 1297 Bishop's Lodge Rd., Santa Fe, 87506 New Mexico		
Subject: The arrow points to the Little Tesuque creek which runs through the property. No 50 ft. buffer or BMP's along some sections of the creek.
